**BLACKSTONE RIVER BASIN
UPTON, MASSACHUSETTS**

**WILDWOOD LAKE DAM
MA 00667**

PHASE I INSPECTION REPORT NATIONAL DAM INSPECTION PROGRAM

APRIL 1979

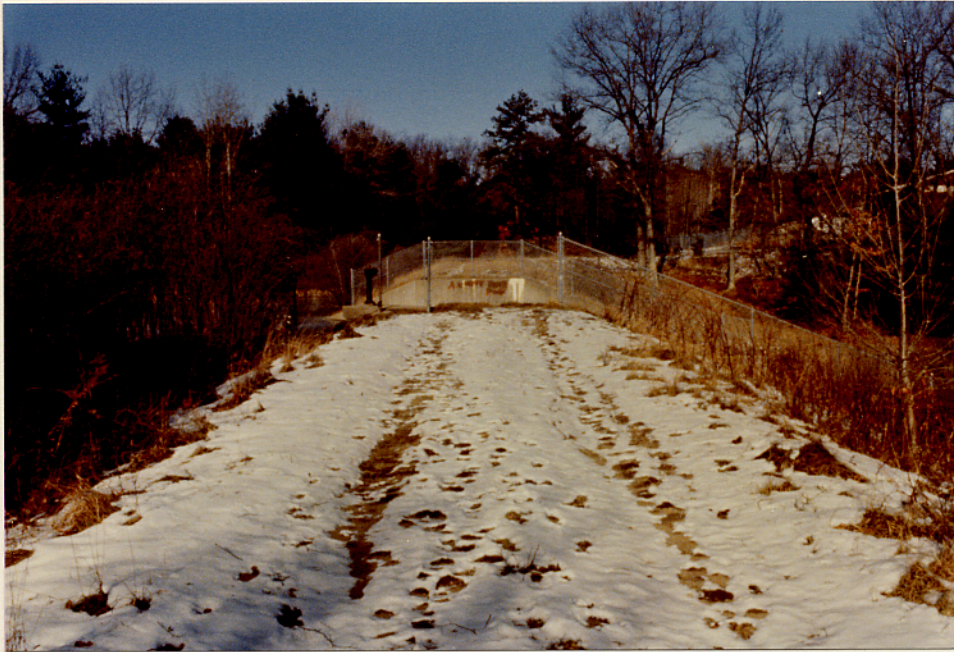
NO. 1 CREST OF DAM FROM RIGHT ABUTMENT

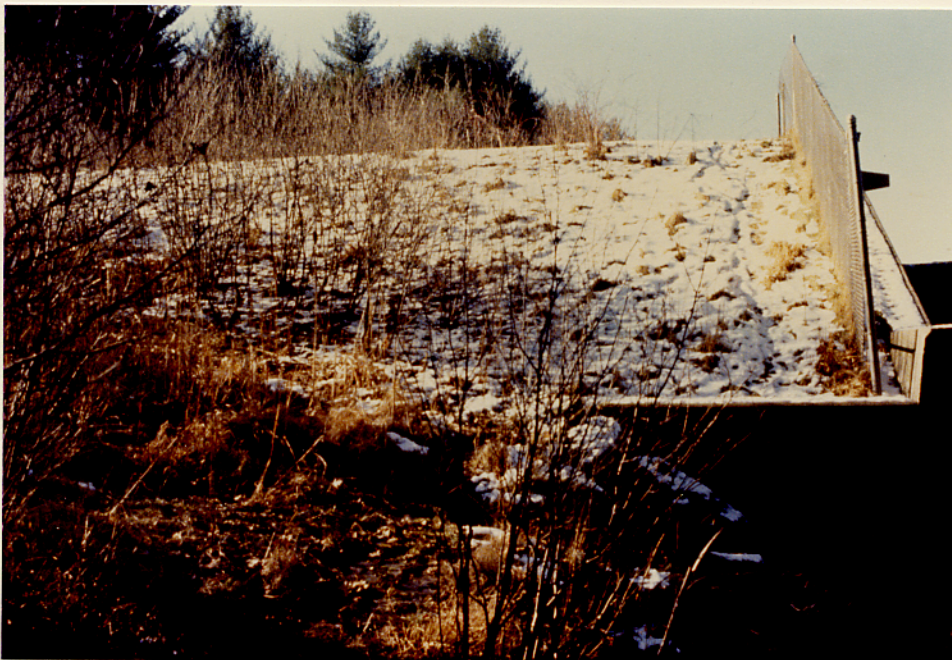
The dam appears to be in fair condition, however, several signs of distress were noted at the site. Seepage through the dam has created a large wet area on the downstream slope of the embankment, to the right of the spillway. This area is overgrown with brush and marsh vegetation and the ground is spongy and soft. A second, smaller area of seepage was apparent in the riprap below the left retaining wall of the spillway.

Early inspection reports on the former dam at this site made frequent reference to leaks through the toe of the dam, and bulging in the downstream wall, particularly along the northerly end of the wall. The wall was apparently repaired in 1928, but the problem of leakage persisted up to the time that the dam failed in 1936. The seepage observable in the present dam may also be caused by leaks through the remains of the old embankment.

**NO. 2 DOWNSTREAM FACE OF DAM, TO RIGHT
OF SPILLWAY (SEEPAGE AREA)**

- 7.2 Recommendations. In view of the concerns on the continued performance of this dam, it is recommended that the Owner employ a qualified consultant to investigate the seepage through the dam, and the severe erosion on the upstream face of the dam near the right spillway wing wall.

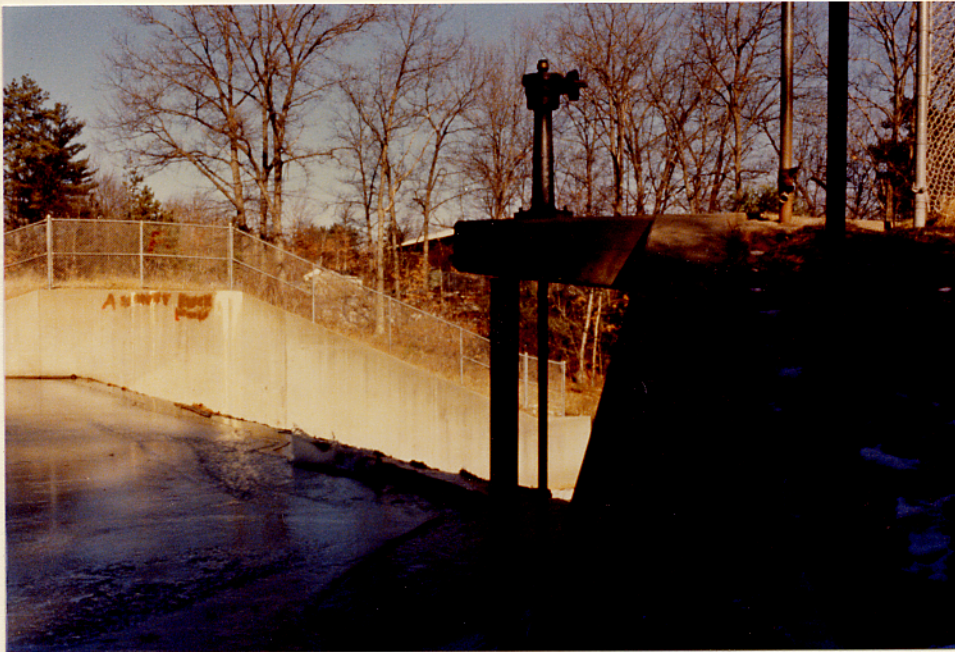
The visible concrete appears to be in good condition. Water flowing over the weir prevented a closer inspection of the outlet, and the gated inlet was submerged. The hand operated sluice gate mechanism is standing on an open platform which overhangs the lake. The mechanism is unlocked, but the hand crank is not kept at the site. The gate apparently has not been opened since the dam was built. Its condition is unknown.

- 4.3. Maintenance of Operational Facilities. The gate appears to be in good condition, but reportedly has not been used since its installation. No problems have been reported at the outlet or on the spillway since the dam was built.

NO. 3 UPSTREAM VIEW OF SPILLWAY AND GATE MECHANISM

- a. open the sluice gate and lower the lake to El 300.0, which is approximately 8 feet below the crest of the spillway. The lake should be maintained at this level until the recommendations and following remedial measures are implemented.

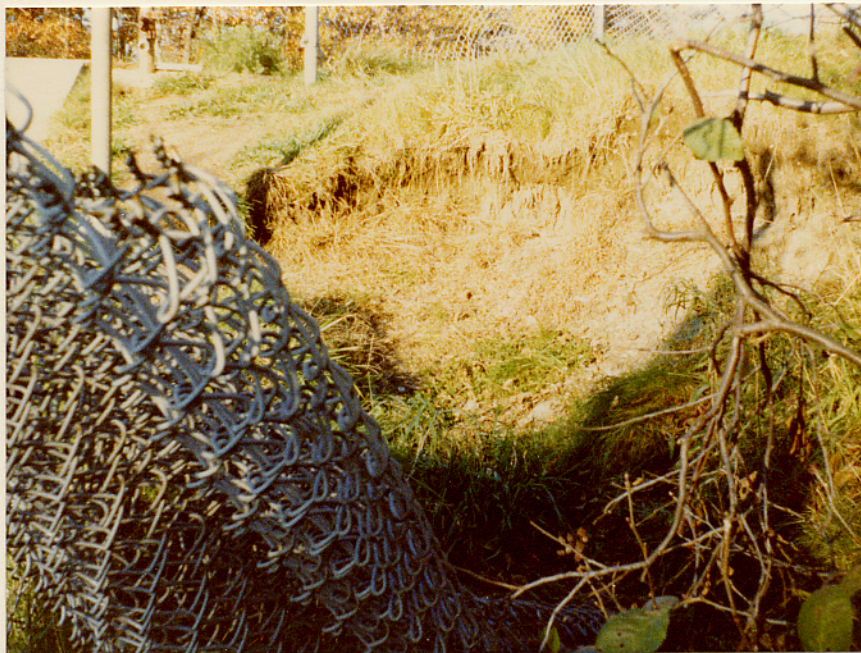
There is a large hole, approximately 6 feet in diameter and 2 feet deep, on the upstream face of the dam above the right wing wall of the spillway. The hole is believed to be due to erosion. The chainlink fence along the wing wall and outlet works has been partially dismantled and should be replaced.

NO. 4 EROSION ON UPSTREAM SLOPE

- b. add riprap to the upper slope of the upstream face of the dam. This would provide complete riprap protection for the entire face of the dam.
 - c. backfill and protect the eroded area on the upstream face of the dam, adjacent to the spillway. Also, repair the erosion on the downstream face of the embankment.

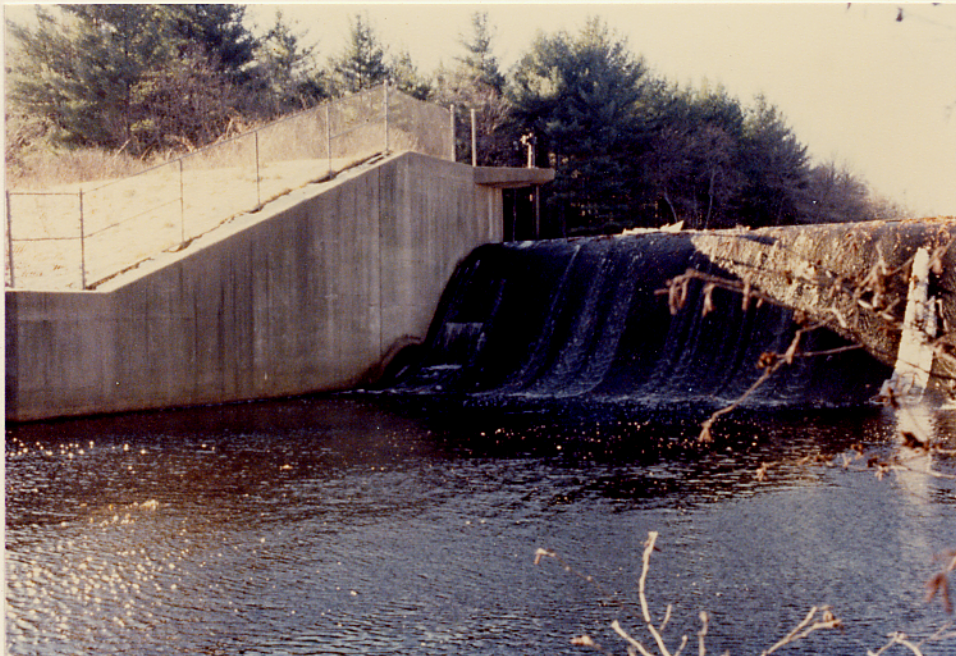
b. Weir and Training Walls	thin concrete walls, ogee weir, chainlink fence on wall encloses weir
General Condition of Concrete	good, except minor erosion at base of training wall, at intersection with weir
Rust or Staining	none
Spalling	none
Any Visible Reinforcing	none
Any Seepage or Efflorescence	none
Drain Holes	none visible - see drawings

NO. 5 OGEE WEIR AND RIGHT TRAINING WALL

- f. repair the fence on the wing wall of the spillway.
 - g. implement a systematic program of maintenance inspections. As a minimum, the inspection program should consist of a monthly inspection of the dam and appurtenances. It is essential that a department in the Town be assigned permanent responsibility for maintaining the dam and operating the gate. All

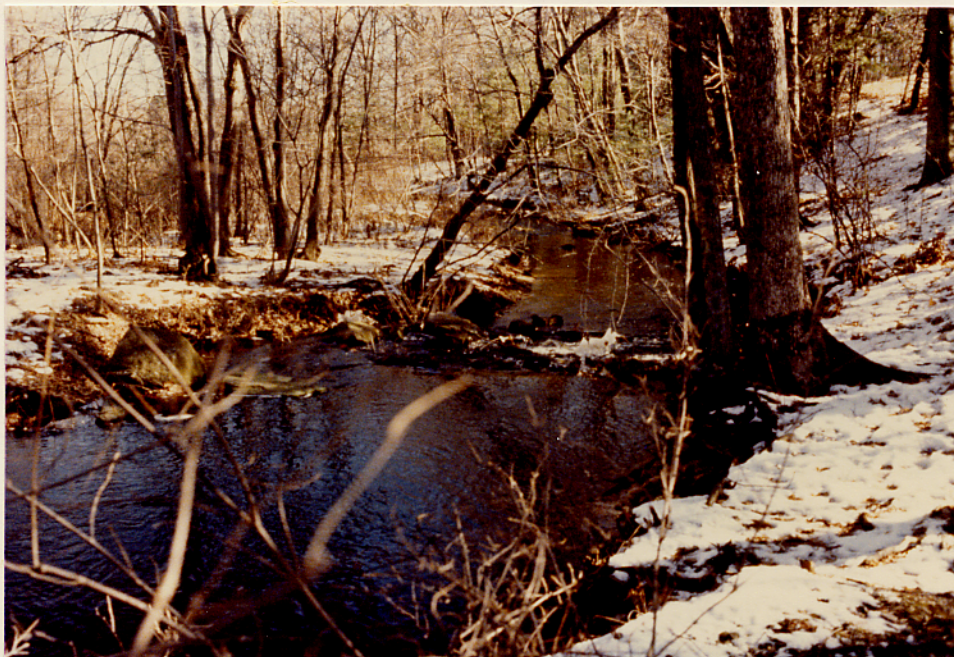
- d. Visual Observations. The dam is relatively new, and the spillway appears to be in good condition. There is no approach channel, and the entrance to the spillway is clear except for minor amounts of debris floating near the crest of the weir. The outlet conduit extends through the spillway and discharges at the downstream face. The mechanism for operating the gate appears to be in good condition, although it is reported that the gate has not been opened since the dam was built. The narrow discharge channel shows some erosion of its banks. Local accumulations of rock and debris do not appear to impede the flow in the channel.

c. Discharge Channel	natural stream channel
General Condition	fair - channel is very narrow & appears to crack at weir
Loose Rock Overhanging Channel	large boulders present on both banks for approx 100' to 150'
Trees Overhanging Channel	Some small trees, up to 4' diameter
Floor of Channel	rock, gravel; banks undercut near spillway - roots exposed on trees
Other Obstructions	accumulation of debris, and material at footbridge about 150' dis of dam across channel

NO. 6 DOWNSTREAM VIEW OF DISCHARGE CHANNEL
